21 July 2003

Hazard to Navigation Caused by Vandalism of Oceanographic Mooring - Newport Oregon

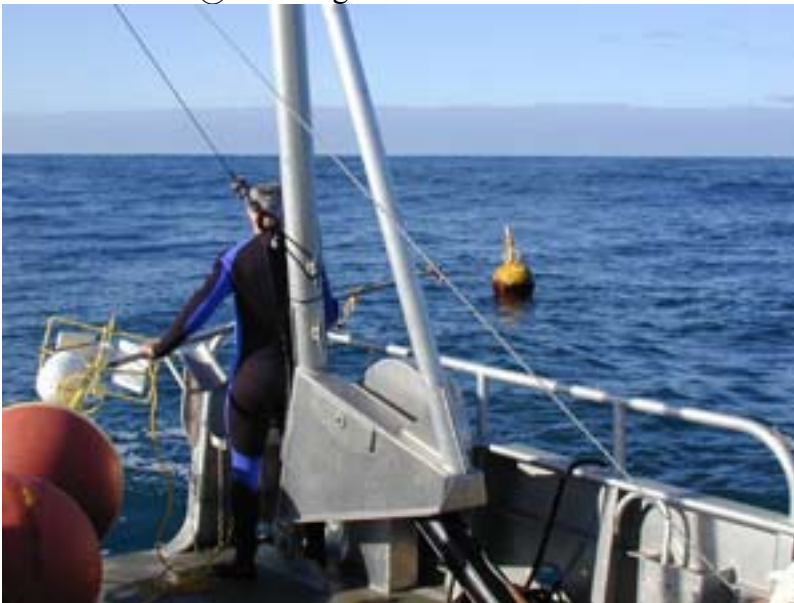
The navigation light and radar reflector on a long term oceanographic mooring were recently stolen, leaving a hazard to navigation. The mooring is ten miles off the Newport coast and is maintained by the College of Oceanic and Atmospheric Sciences, Oregon State University. When the light and radar reflector are gone, the steel surface float and remaining heavy tackle represent a significant hazard to vessels. This has been reported to the U.S. Coast Guard and warnings are being broadcast on VHF radio. An effort is being made to make the necessary repairs as soon as possible.

Figure 1. Showing buoy during previous repair effort - this is the fourth time this mooring has been vandalized. Note that the vertical spar has been broken off.
